## Learning from Earthquakes

# The Kashmir Earthquake of October 8, 2005: Impacts in Pakistan

An EERI reconnaissance team comprising Saif Hussain, Coffman Engineers, Inc., Encino, California; Ahmed Nisar, MMI Engineering, Oakland, California; Bijan Khazai, Columbia University, Earth Institute; and Grant Dellow, Institute of Nuclear and Geological Sciences, New Zealand, visited Pakistan November 13-20, 2005. During the visit, the team was hosted by the North West Frontier Province (NWFP) University of Engineering and Technology (UET) and spent four days in the earthquake-affected areas of northern Pakistan. NWFP UET staff included Dr. Qaisar Ali, Syed M. Ali, and Mr. Mansoor Khan. The trip included a helicopter survey of the area courtesy of the Pakistan Army. The team also attended a two-day international conference on the earthquake organized by the NWFP UET in Islamabad and met with the Prime Minister of Pakistan at the PM

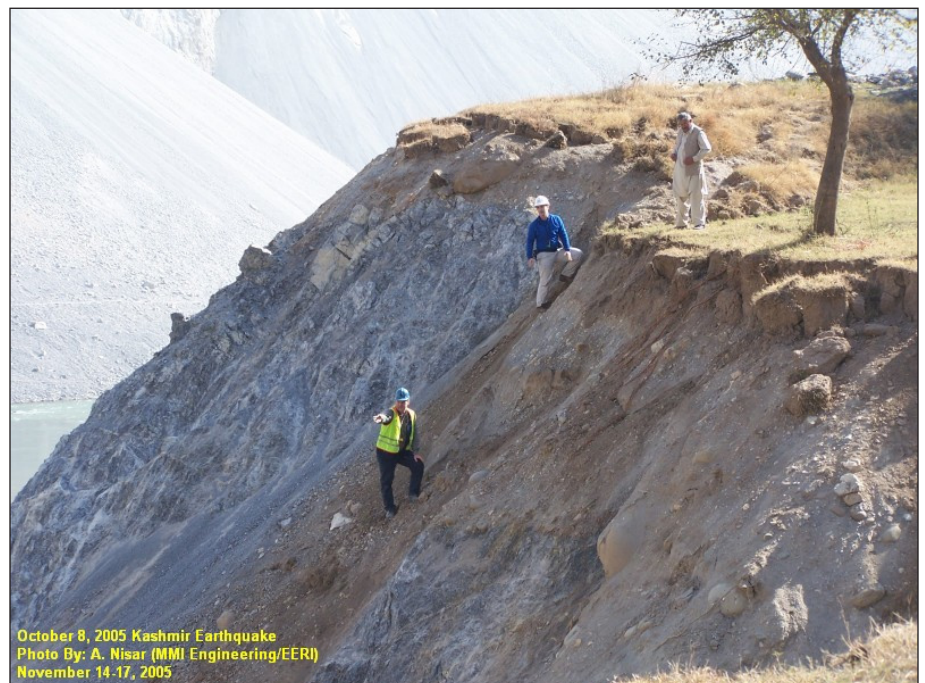
**Figure 3.** Localized zone of uplift.

The surface trace of the causative fault can be interpreted from the map of ground displacements from radar amplitude measurements (COMET 2005). The surface expression of the fault can also be clearly detected in images of lithology change from Landsat data. A 3-D relief projection shows the expression of this fault not only in the surface geology, but also in the surface geomorphology. Figure 3 shows ground deformation that appears to be tectonic in nature, possibly but not necessarily associated with the main rupture trace.

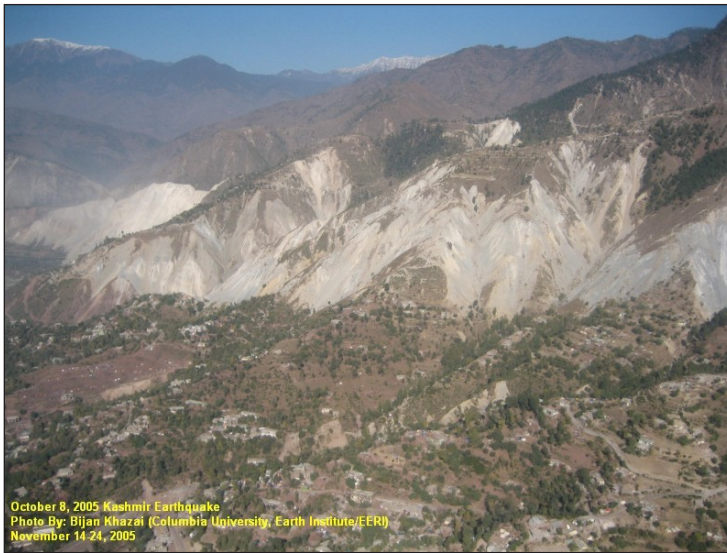
**Figure 4.**  
*Landslide  
concentration  
along mid-  
slopes.*

Landslide concentrations along the rupture zone were very high, but quickly dissipated within as little as 2 km of the surface projection of the fault. During the aerial reconnaissance of the affected area, landslide damage appeared to be most severe on the hanging wall, with relatively low concentrations on the footwall side. A very high concentration of large and small landslides was observed in the mid-slope area along the surface projection of the fault (Figure 4).

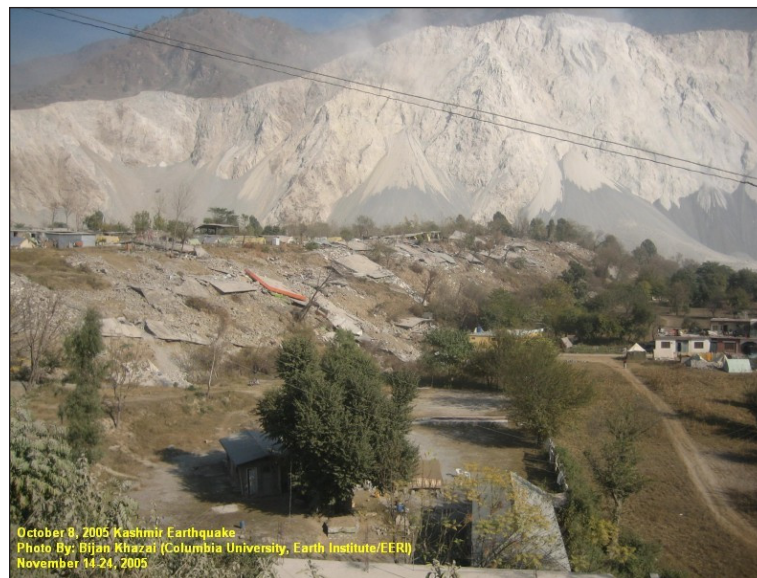
**Figure 5.**  
*Note mas-  
sive land-  
slide in the  
background,  
completely  
collapsed  
structures  
in the fore-  
ground with  
only roofs  
intact.*

Most building damage resulted from ground shaking, though a large number of buildings located mostly on or near slopes were destroyed by ground failure due to landsliding or subsidence (Figure 5). The largest concentration of destroyed or damaged buildings was in Muzaffarabad and Balakot. Other cities such as Bagh and Rawlakot also had significant damage, but were not visited by the EERI team due to limited time. It is estimated that in Muzaffarabad, 30-50% of the buildings were either destroyed or badly damaged in the main event. Major damage concentrations in Muzaffarabad were in areas of deeper allu-

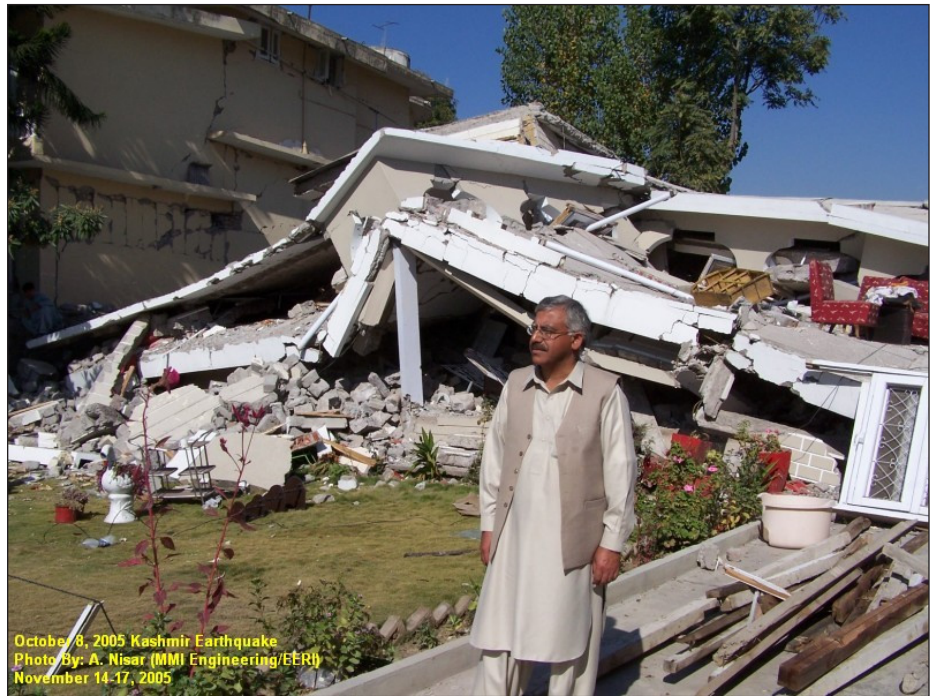
**Figure 6.** Man in front of his sister's house in Muzaffarabad that collapsed and killed her. Masonry bearing wall construction.

below grade and 18 to 24 inches wide. The only steel reinforcing found in most of the bearing wall construction is in lintels (window or door headers), and normally consists of four #4 bars in a 9 x 9 concrete beam with stirrups or ties at 9-12 inch spacing. Typically, no bond beams are part of the wall and no positive ties exist between the walls and the floors/roofs. The performance of the URM wall buildings in the earthquake was varied and seems to have depended on factors such as redundancy in structural walls and quality of materials and construction (Figure 6).

In areas of strong shaking, most stone masonry-bearing wall structures collapsed or suffered severe damage. A majority of these structures were constructed of non-dressed round stones with mud or weak cement mortar. The weakness of the mortar was clearly evident; the mortar would crumble even when manipulated with bare hands. Issues with concrete block construction were poor block

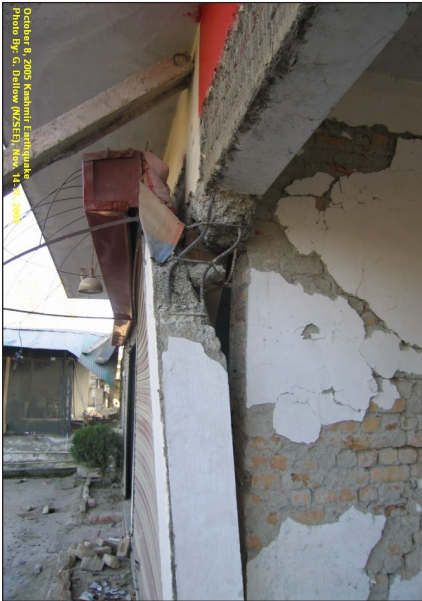
**Figure 7.** Failed column at a storefront showing three aspects of damage: (1) column failure; (2) soft/weak story at storefront; (3) infill walls preventing total collapse of building.

**Framed Construction:** A small percentage of buildings in the area, mostly larger multistory buildings in the larger towns, are nonductile reinforced concrete stick frame construction with nonstructural infill block or brick walls with plaster finish (Figure 7). The floors are mostly of beam and slab construction supported by columns resting on pad foundations. There is no lateral force-resisting system, and it is mostly infill walls that provide some amount of lateral strength and stiffness. A number of buildings, some of them three or four stories tall, were seen resting entirely on “nonstructural” infill walls while the columns had failed just below the first elevated floor. Many soft/weak story failures were observed in mixed use multistory buildings with open storefronts at the first/ground floor level and walled office/residential space in the upper stories.

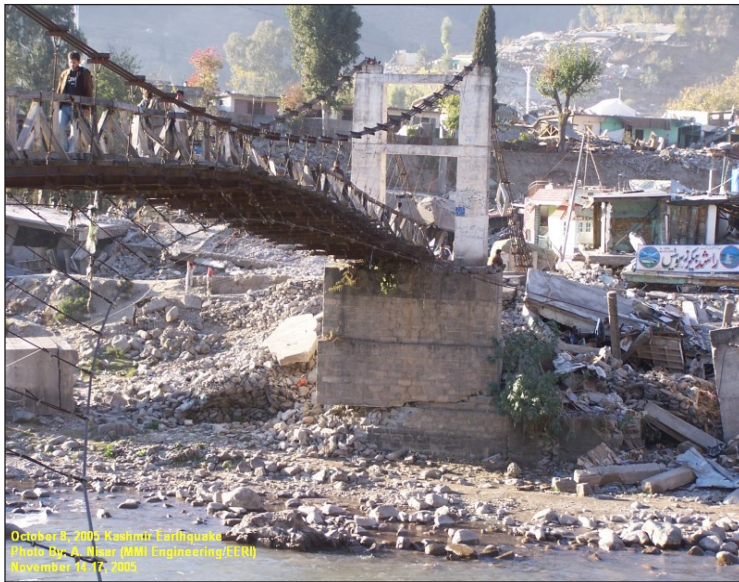
**Figure 8.**  
*Shearing failure of bridge tower foundation, Balakot.*

bridges. The former consist of a wood deck supported on steel girders suspended by steel cables on either side of the deck. The cables are supported by a tower at each end and anchored in a concrete anchor block. In addition, the deck is prevented against sway by cables attached to a longitudinal cable on each side below the deck elevation and anchored in concrete anchor blocks. The suspension bridges are typically for pedestrian use, with some allowing vehicular traffic. Damage to suspension bridges ranged from shearing of the tower foundation (Figure 8) to complete collapse of the towers (Figure 9).

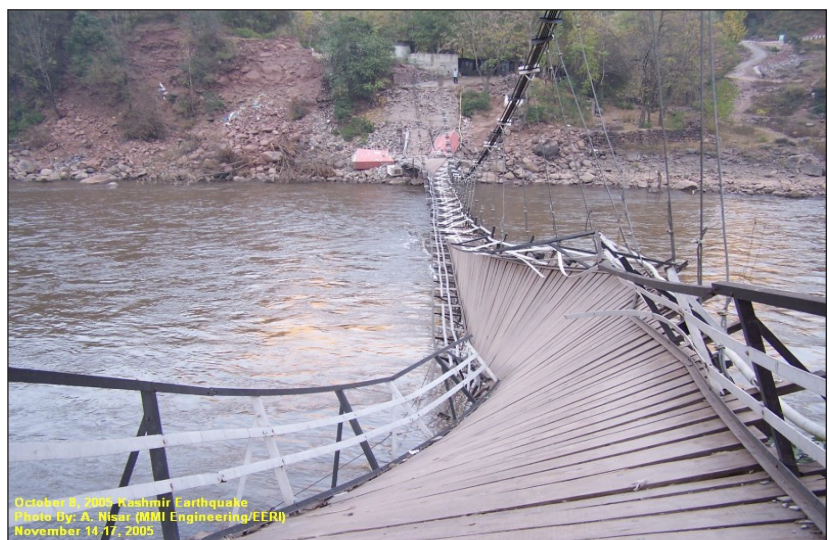
**Figure 9.** *Collapsed suspension bridge, Jhelum Valley.*

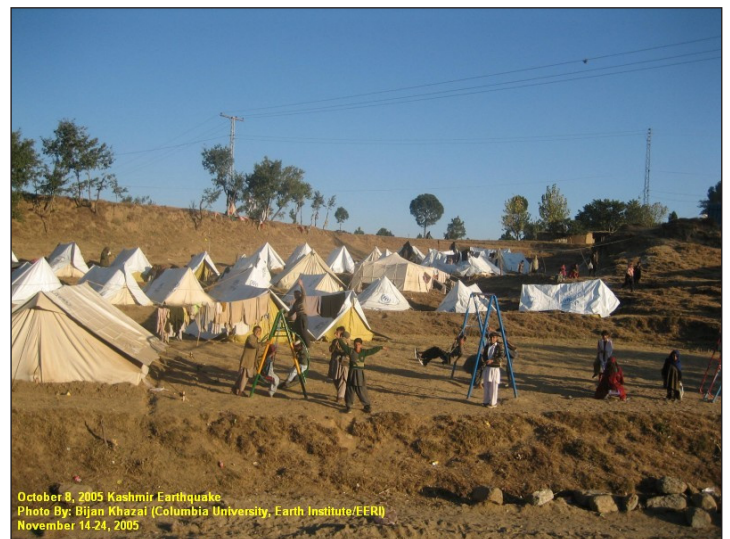
**Figure 10.** Children in makeshift playground in front of their tent camp. White plastic sheets have been added to the tents to protect against rain.

Shelter strategy was organized around three populations: people who lived in houses in the lower elevations, people living in higher elevations who could come to the lower elevations, and people living in inaccessible snowline areas (5,000-7,000 feet). People in the former two categories were provided with tented villages managed by some agency (Figure 10). People in the last category were not compelled to descend to the tented villages. Survivors are being taught to build transitional shelter using material from retrieved debris,

reinforced with locally available materials such as timber and hay in addition to the corrugated galvanized iron (CGI) sheets provided to them.
